EPRI GS-7325  
Project 1745-15  
Final Report  
May 1991

# **Operation and Maintenance Experiences of Pumped-Storage Plants**

Prepared by  
MORRISON-KNUDSEN ENGINEERS, INC., San Francisco, California

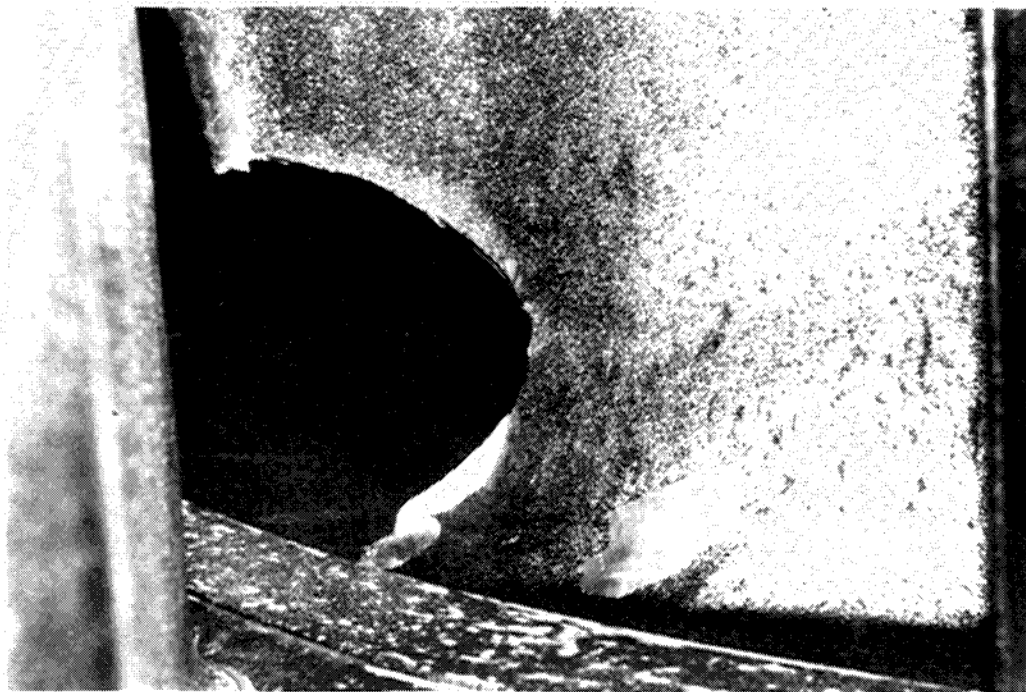
MUDDY RUN

Cracking of the Runner Bucket

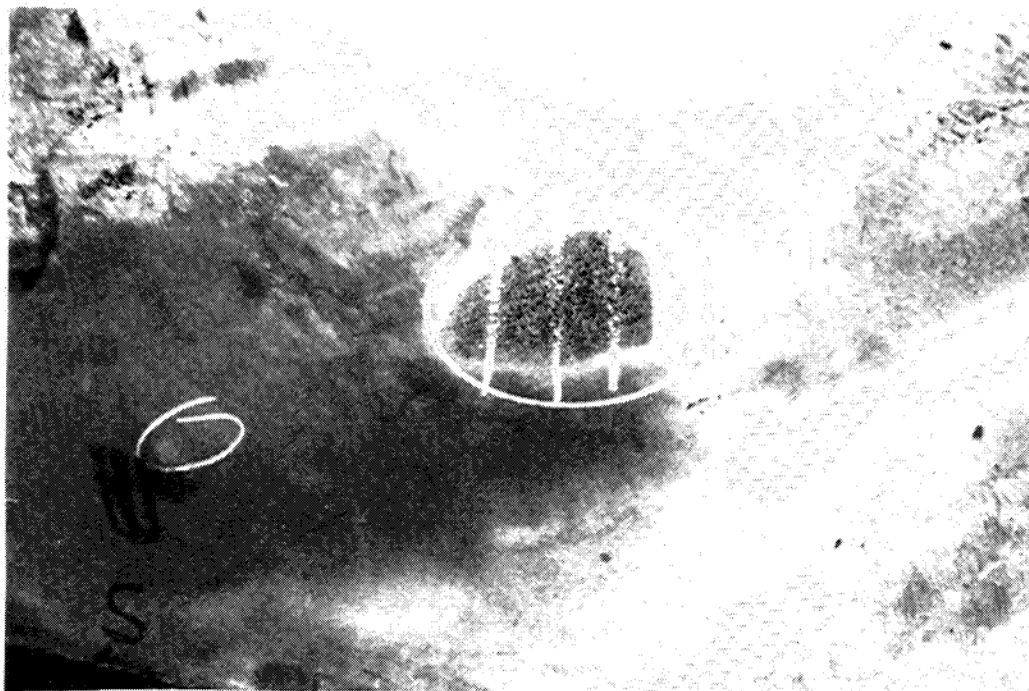
BEAR SWAMP

Cavitation on Suction Side of the Runner Bucket

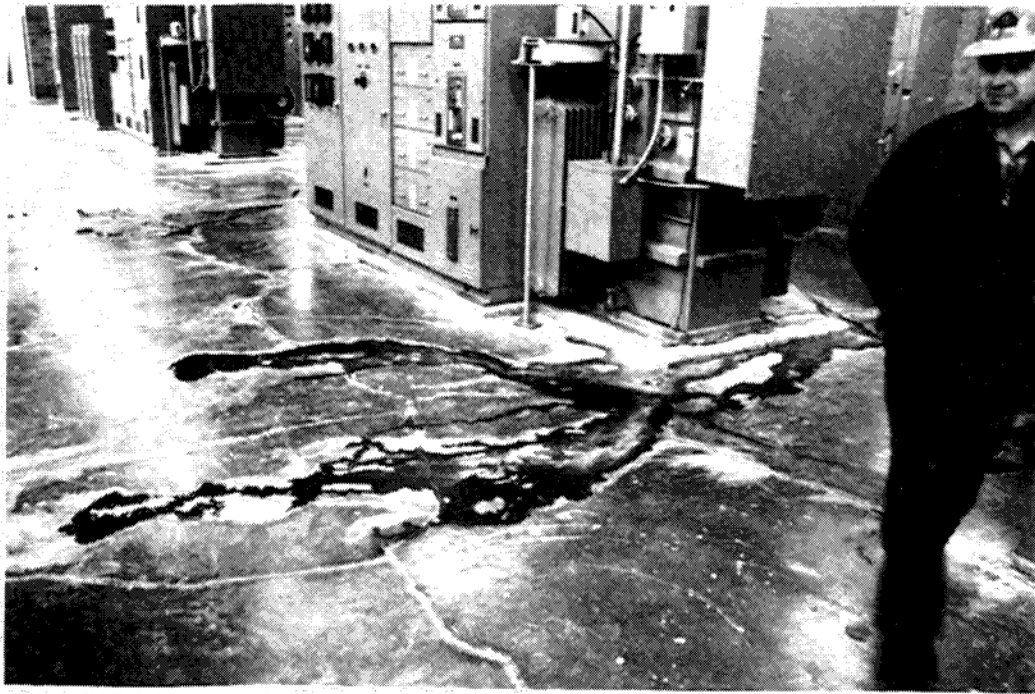
FAIRFIELD

Floor Cracks in the Electrical Gallery

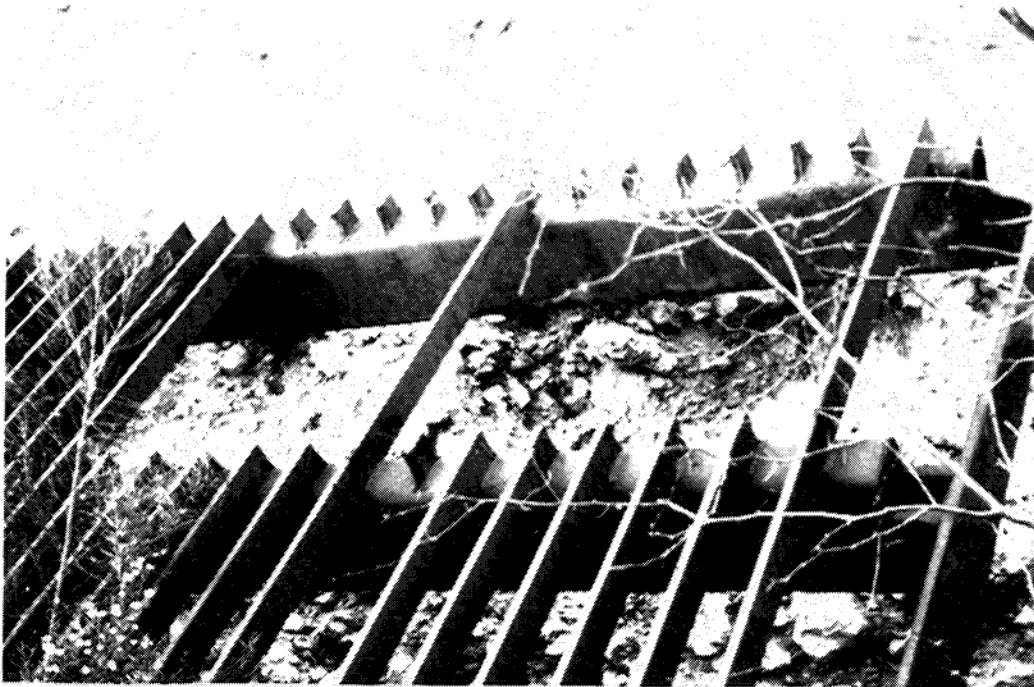
MORMON FLAT

Damaged Trashrack

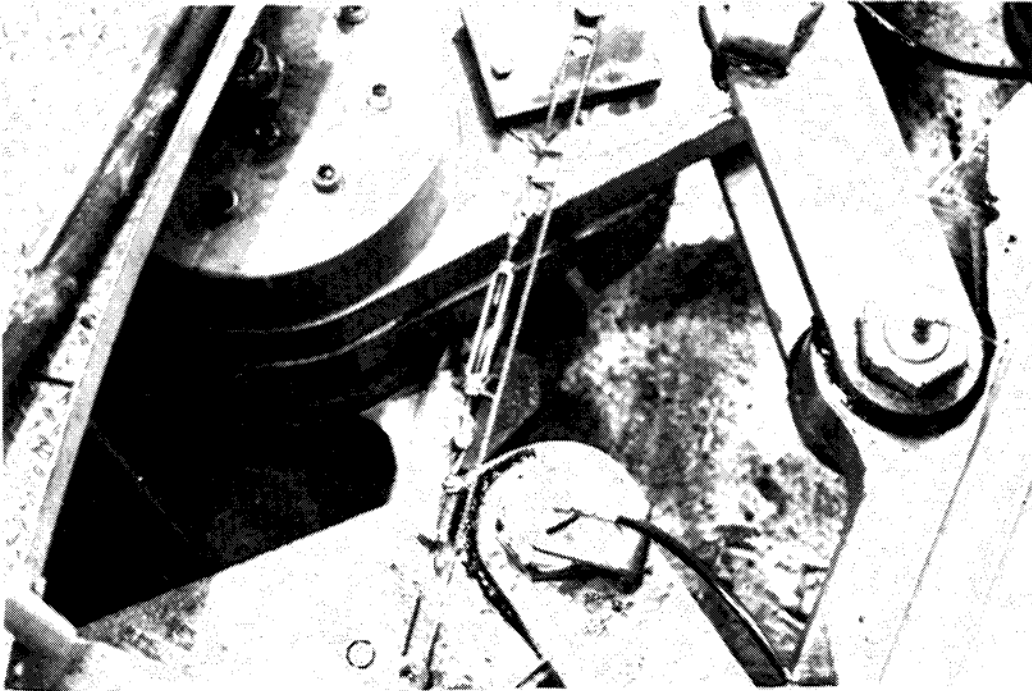
SENECA

Gate Mechanism with Cables to Reduce Wicket Gate Vibration

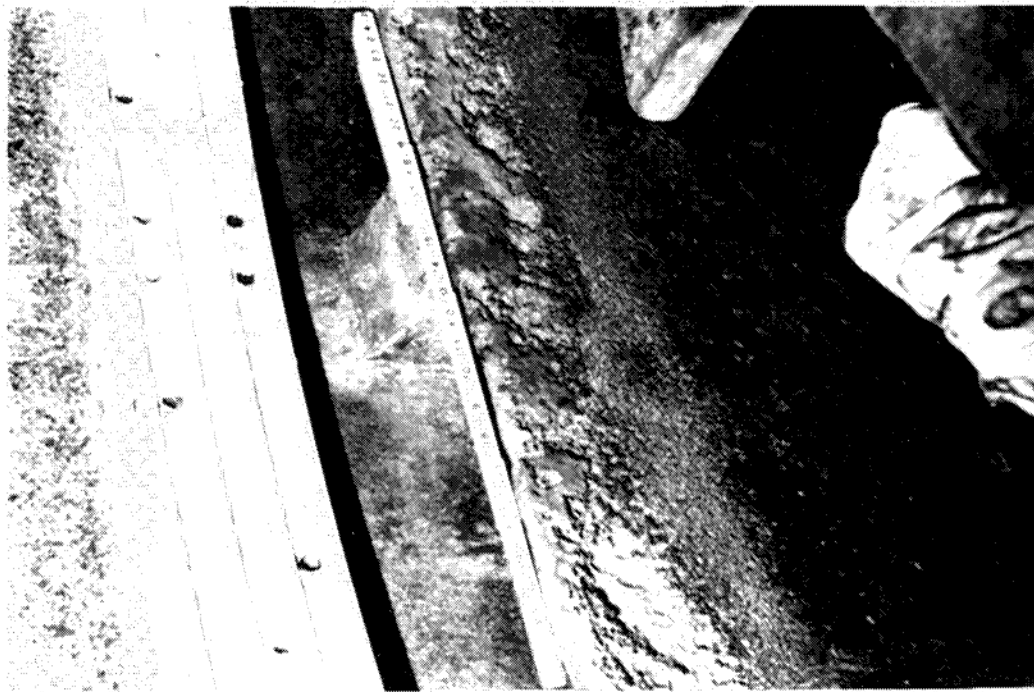
MUDDY RUN

Cavitation Damage at Top of the Draft Tube Liner

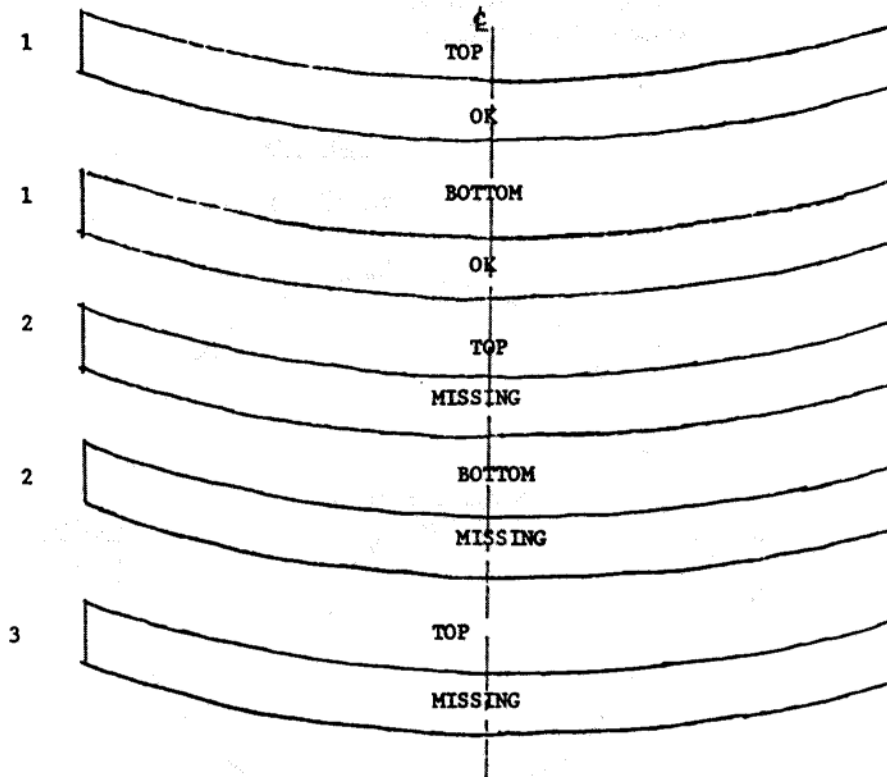
Unit # 2  
Wicket Gate Seal Cavitation

Gate #	Top	Date Replaced	Bottom	Date Replaced
1	OK	10-20-81	OK	10-20-80
2	Miss	8-9-79	Miss	8-9-79
3	Miss	11-12-73	Miss	10-20-80
4	OK	10-8-76	OK	10-20-80
5	OK	10-8-76	Miss	10-20-80
6	OK	10-8-76	Miss	10-20-80
7	OK	Original	OK	10-20-80
8	OK	8-30-78	OK	10-20-80
9	OK	10-20-80	Miss	Original
10	OK	8-9-79	Miss	10-20-80
11	Miss	Original	OK	10-20-80
12	OK	10-20-80	Miss	10-20-80
13	Miss	10-4-77	OK	11-12-73
14	OK	10-20-80	Miss	10-20-80
15	Miss	8-9-79	Miss	10-20-80
16	OK	8-9-79	Miss	10-20-80
17	Miss	Original	Miss	Original
18	OK	10-20-80	Miss	10-20-80
19	OK	8-30-78	Miss	10-20-80
20	Miss	3-13-74	Miss	10-20-80

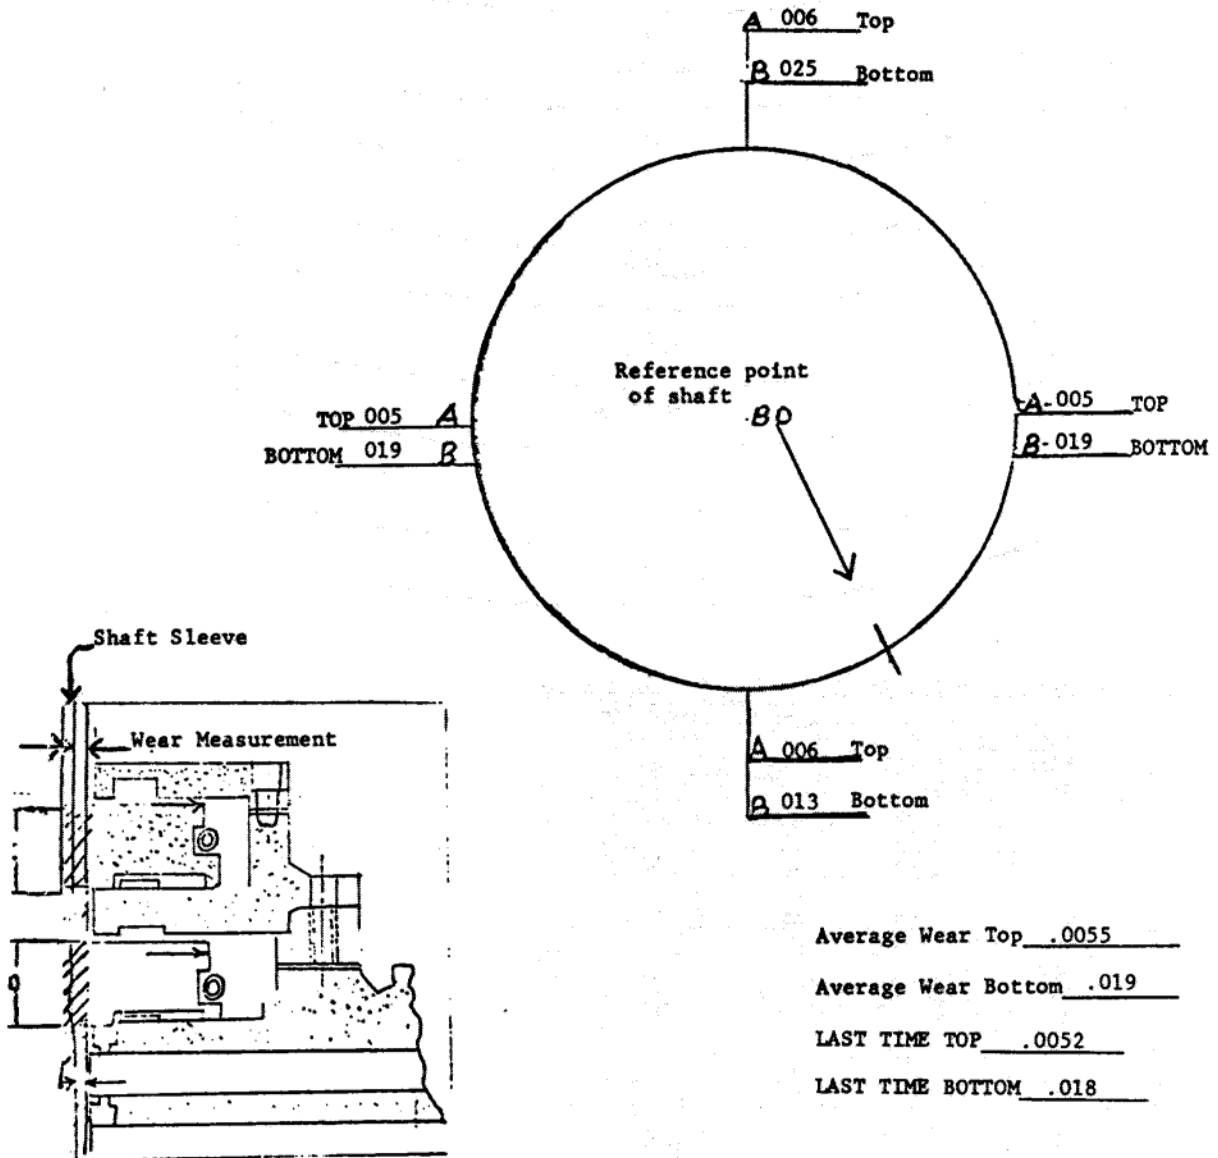
Wear of Shaft Sleeve at  
Carbon & Resin Packing

Average Wear Top .0055

Average Wear Bottom .019

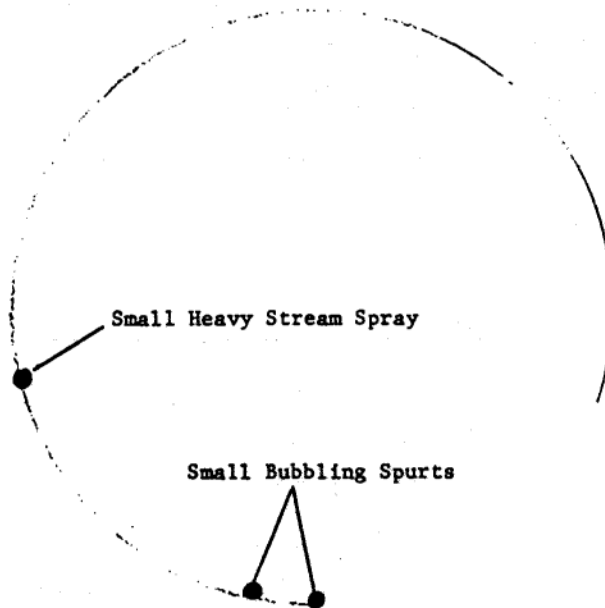
DOWNSTREAM  
SEAL LEAKAGE  
UNIT # 2

Total Leakage

4400 Milliliter Min.
